SCHOONER *C.A. Thayer*

Historic Structure Report 1991
DRAFT

San Francisco Maritime National Historical Park

Prepared by
Tri-Coastal Marine, Inc. 200
Burrows Street
San Francisco, CA 94134

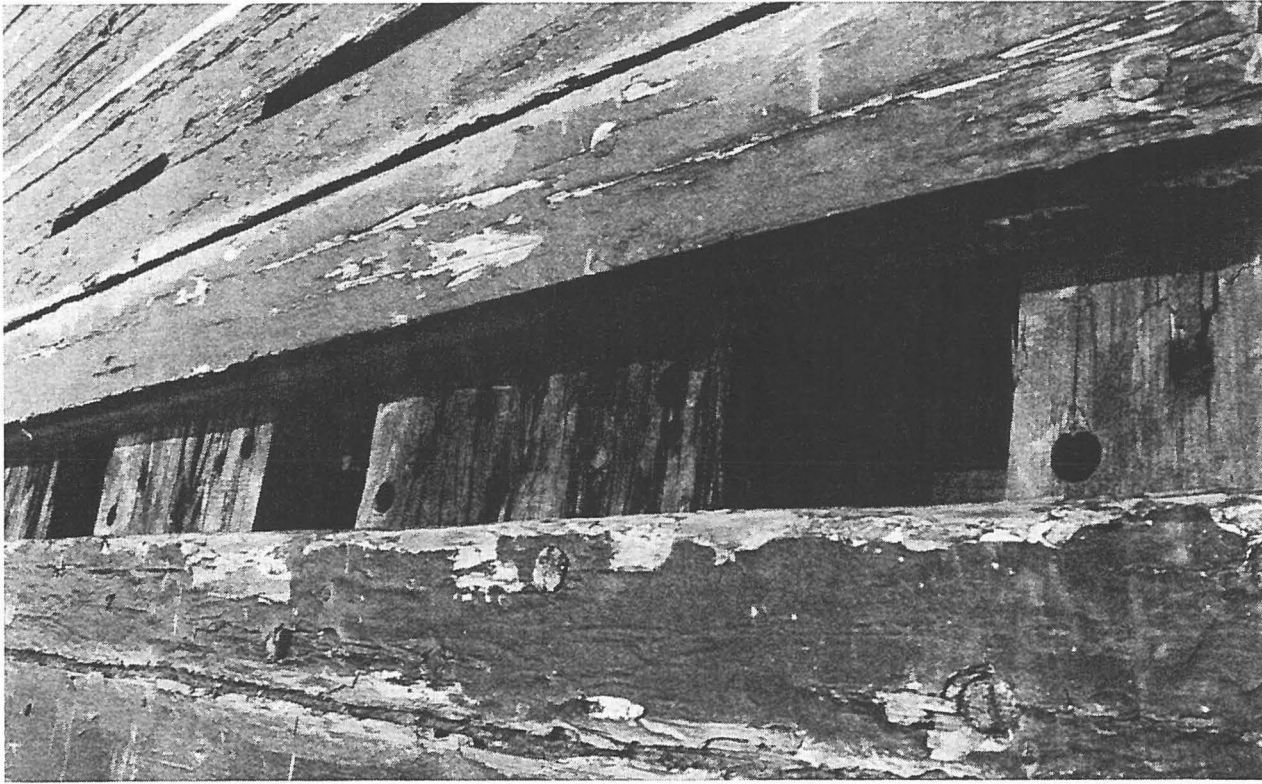
Fig. 16. General decayed condition of upper frames as seen during hull repairs in 1987. Note wedged trunnels in plank below opening.

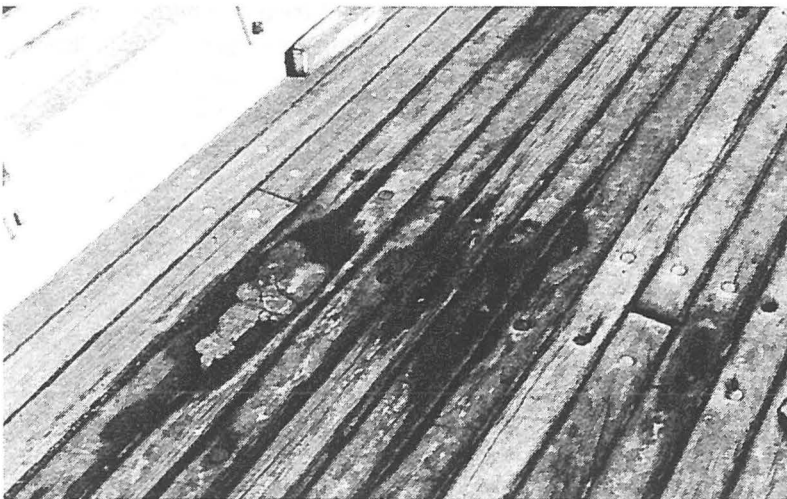
Fig. 17. Main deck planking showing rotten areas at fastenings. Line of fastenings indicates location of deck beam beneath. Leakage in these areas has resulted in decay of decking and deck beams.

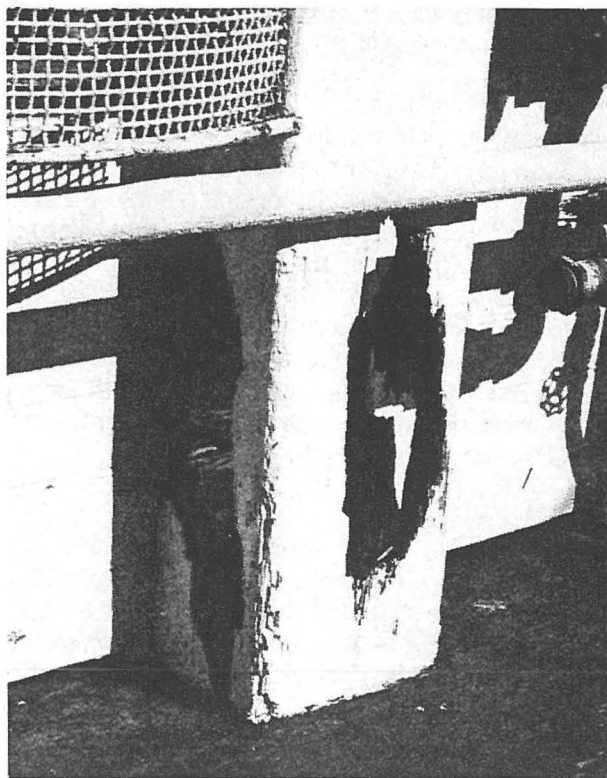
Fig. 18. Typical condition of bulwark stanchions prior to preservation work in 1987. Photo: Tri-Coastal Marine

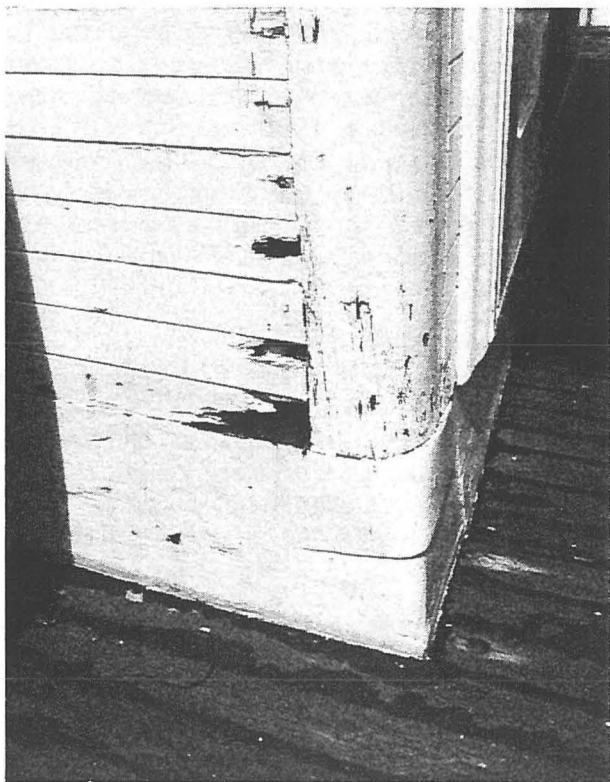
Fig. 19. Port aft corner of deckhouse; rot at the ends of tongue-and-groove sheathing and at base of corner posts. The massive sill timber beneath is also partially decayed at corners. Photo: Tri-Coastal Marine

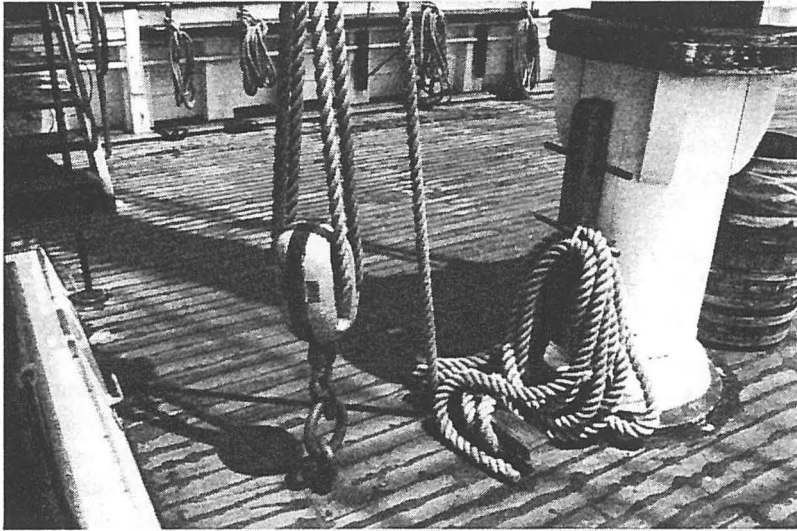
Fig. 20. Mainmast and fore sheet. Rig is in good condition, with new running rigging rove off in 1989.

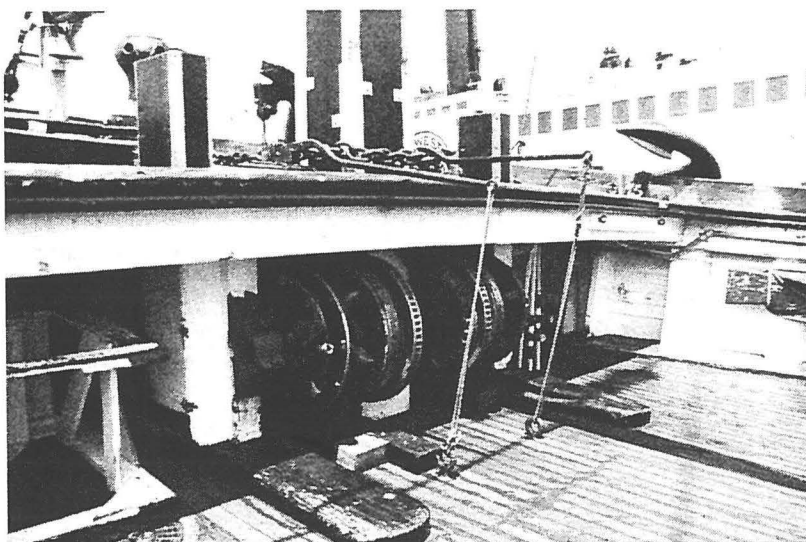
Windlass: The windlass is believed to be original. It appears to have been power-driven at one time during the vessel's later working career. Portions of the power take-off (gears and belts) are now gone, but the windlass remains manually operable. The windlass is corroding due to inadequate protective coatings. The cross head (on the forecabin head deck) is cracked and rusted, but is still operable. The clutch mechanisms are frozen and inopera-

Fig. 22. Anchor windlass beneath forecastle head, looking forward on the port side.

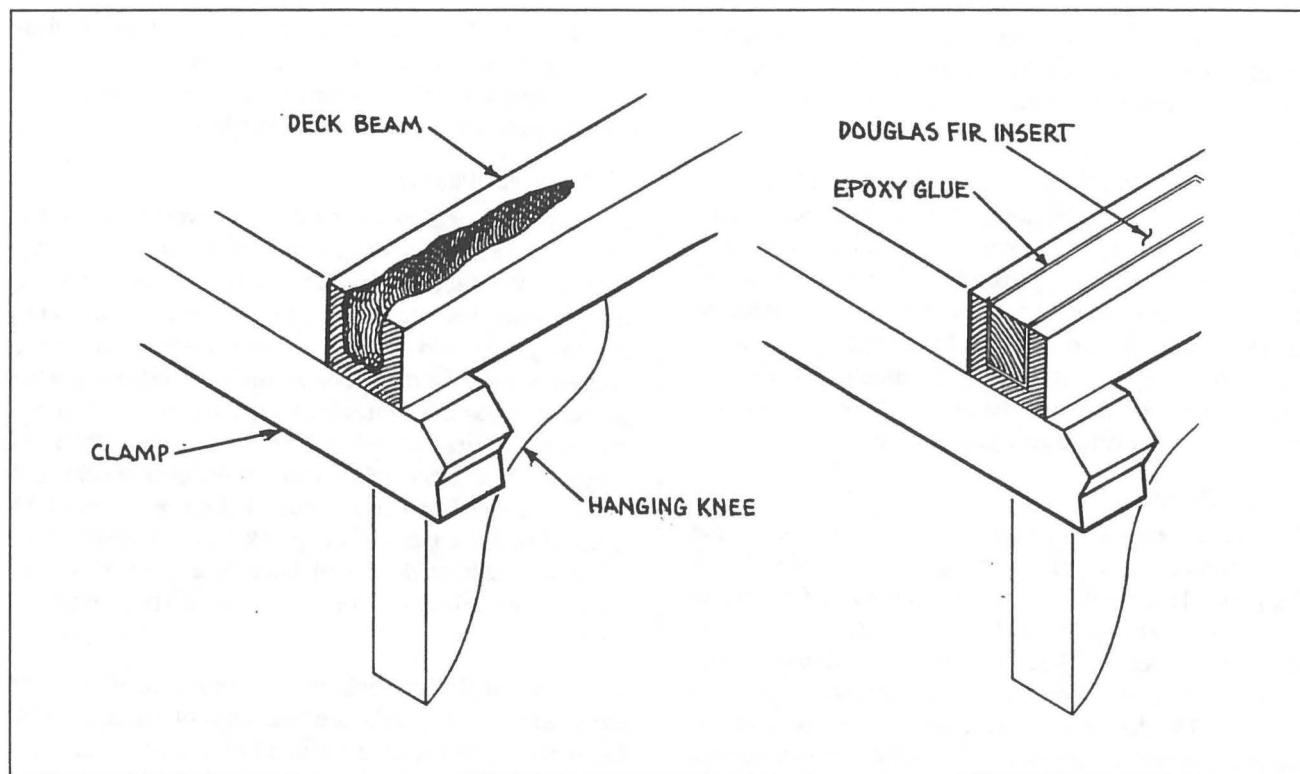
curred in the soft wood, while the denser wood is left largely intact. This condition lends itself to the use of epoxy consolidation techniques which can fill in the gaps left by decay.

To preserve the knees, they would be removed by driving out the clench bolts fastening them to the deck beams, clamps, and ceiling. If the knees have nail sickness damage around the fastenings, the fastening holes would be drilled out and plugged with wood dowels bedded in epoxy, then re-drilled for new fastenings. Rotten areas would be repaired using epoxy compounds. While this sounds like a lot of work, the process may be less effort than milling and fitting new grown knees.

Fig. 26. and Fig. 27. Deck beam restoration.
